GEOTECHNICAL PROBLEMS OF THE CULTURAL HERITAGE MONUMENTS IN BULGARIA

ABSTRACT

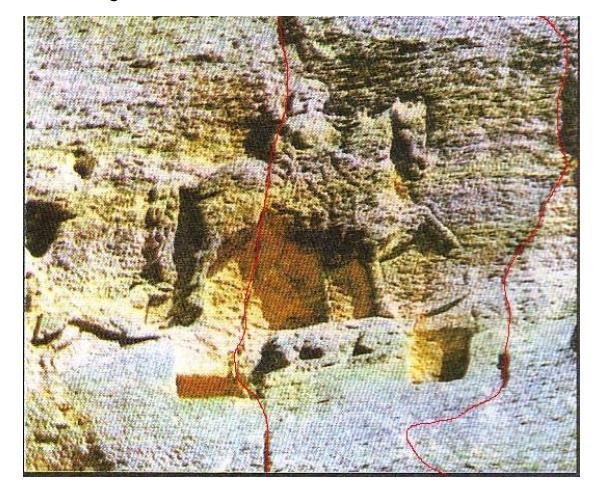
One of the most endangered monuments is the Madara horseman bas-relief. It is carved in the limy sandstones of the western cliff of the Madara plateau. (fig. 1). Its existence is effected by the geological processes related to the natural development of the cliff and to its surface weathering.

Figure 1. View from the Madara horseman and the contours of the rock block.

Another significant problem is the biologic degrading of the rock due to micro-organisms decomposing the surface layer of the cliff. The process is quite vigorous and if not stopped in the following 1-2 decades all other interventions will be senseless. Our studies revealed that the microflora and microfauna populations are developed due to the changes in the humidity regime of the air and the rock respectively. During the geophysical electrical surveys it occurred that the resistivity of the lower quarter of the cliff is several times lower of those from the other levels of the cliff. The change of the environmental equilibrium after artificial foresting the toe of the plateau at the 30-ies of the last century was estimated to be the major cause for that.

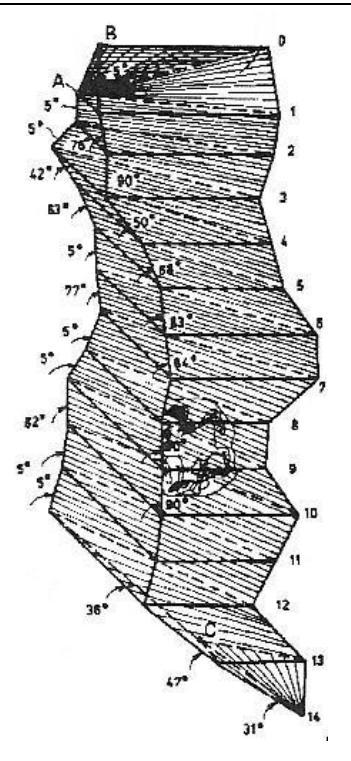
The level of the cliff bearing the bas-relief had finished its second stage of development. A vertical fracture that crosses the bas-relief joins a neighbour one located at 1 m south. The two fractures completely separate a block in the massif that being interlocked with the adjacent blocks is actually stable (fig. 2). The stability calculations reveal that a strong earthquake could loosen the block ant it would fall out with a significant portion of the bas-relief. The estimated total stabilizing horizontal force is about 2300 kN. The technical solution is the anchoring the rock block.

Figure 2. 3D model of the rock block bearing the Madara horseman

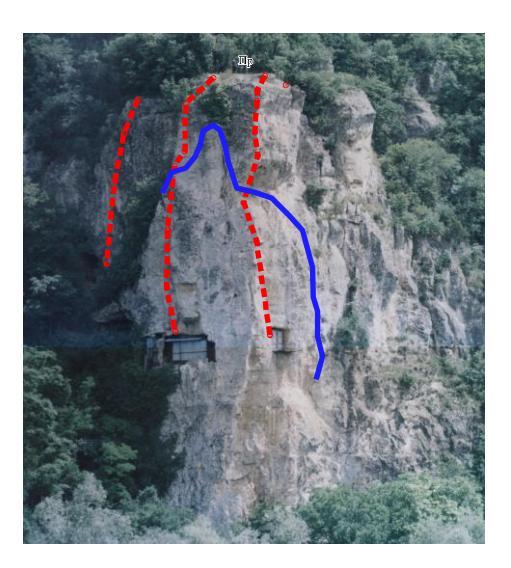
Considerable similar problems exist at the site of the lvanovo rock churches. The religious complex was carved in the limestone cliff of the Canyon of Cherni Lom River. The rock Monasteries (churches) are located in additionally enlarged and shaped karstic caves. With the time blocks falling has occurred from the ceilings and the walls. In most of the churches the processes are irreversible. Real possibilities exist to preserve the tourist site "The Church" only if appropriate enforcing intervention is realized. The studies revealed the seismic and gravitation character of the development of the massif – strong earthquake induces rock blocks falling down. Practically this means that for long time periods there should not be disturbing movements while during an earthquake a massive block fall is expected.

Figure 3. View to Ivanovo rock church and the contours of the external block and survey profiles.

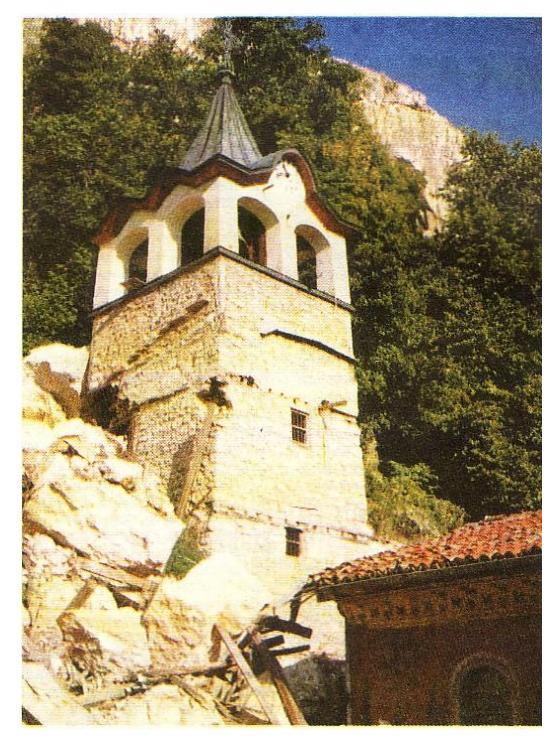
The site of the Preobrajenie Monastery complex including the "The Assu" Church as a cultural monument famous with its frescoes named "The Circle of Life" and the bell-tower built-up by the famous Bulgarian constrictor Koljo Ficheto also is exposed to complicated geotechnical conditions. The Monastery was established in the XIVth century. It was located north of Veliko Tarnovo on a deluvial plane level at the toe of a picturesque 120 m high limestones cliff of the canyon the Yantra River. The Monastery was partially destroyed after the falling of rock block during the Gornooryahovo earthquake in 1913. In 1974 a landslide developed in the deluvial slope completely destroyed the eastern wing of the complex and directly endangered the Church. In consequence the landslide was reinforced by back ties and drainage gallery. In 1991 as a consequence of intensive rainfalls a 300 m³ rock-fall occurred from the cliff and completely destroyed the western wings of the Monastery. No casualties occurred by chance. The chance preserved the Church when the rock flow was divided to two by a tree and run beside its sides (fig. 4).

Figure 4. View to Preobrajenie Monastery bell-tower after the rock-fall in 1991

The geotechnical problems of the Preobrajenie Monastery are very well studied. All practical aspects are embraced: strength of the massif, seismic microzoning, static and dynamic stability of the cliff including with FEM, prognosis for the cliff development was stated. On the base of variants studies a project for cliff reinforcement was designed. Regardless of the fact that at certain moment the financing was secured the project was not realized.

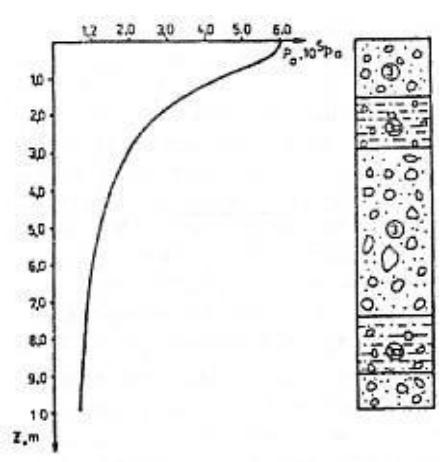
Three initial hypotheses for the destructing factors were tested: overall failure of the stability of the terrain; suffusion settlements of the terrain; local and total failure of the bearing capacity of the soil (fig. 5).

The calculations results rejected the first two of them. The comparison between the foundations loading and the soil bearing capacity revealed that they are very close in range while the foundation loading is higher that the dynamic bearing capacity of the soil. So it was accepted that structural failures are consequent to a local stability failure of the soils probably initiated from the Krupnik earthquake in 1904. Further they continued due to creep processes in the soft clay interlayers. In 1934 the construction of abutments at the eastern and southern walls probably stabilized the structure. During the 60-ies parts of them were demolished and

that caused new activation of the movements. Before any action for reinforcement of the monastery buildings it is necessary to decrease the loads on the soils. The possible technical solutions include widening of the foundation and/or meliorating their bearing capacity by micro-piles.
