ASSESSMENT OF THE ANTHROPOGENIC IMPACT ON THE CHERNA MESTA RIVER SYSTEM DURING THE FLASH FLOOD OF MID-2019

Yanko Gerdzhikov, Zornitsa Dotseva, Dian Vangelov

ABSTRACT. The lower parts of the Cherna Mesta river watershed are often affected by flash flood events. While anthropogenic structures have negligible size when compared to the length of the river, they significantly influence river behaviour at times of floods. Based on field data and analysis of satellite and aerial imagery, we have analysed how structures, such as water intakes and artificial banks, have affected river-related processes, such as erosion and sedimentation, at the time of the mid-2019 flash flood event. The highest artificial construction - the water intake for the Belmeken artificial lake - is situated at an elevation of 1,900 m. This structure not only limited the water power but also acted as a site of deposition of debris transported by the stream. Another water intake structure is located just below the confluence of the three main tributaries (the Sofan Dere, the Dautitsa, and the Leevshitsa rivers) and supplies water to the power plant located at 1,080 m a.s.l. This facility is situated at a place whe

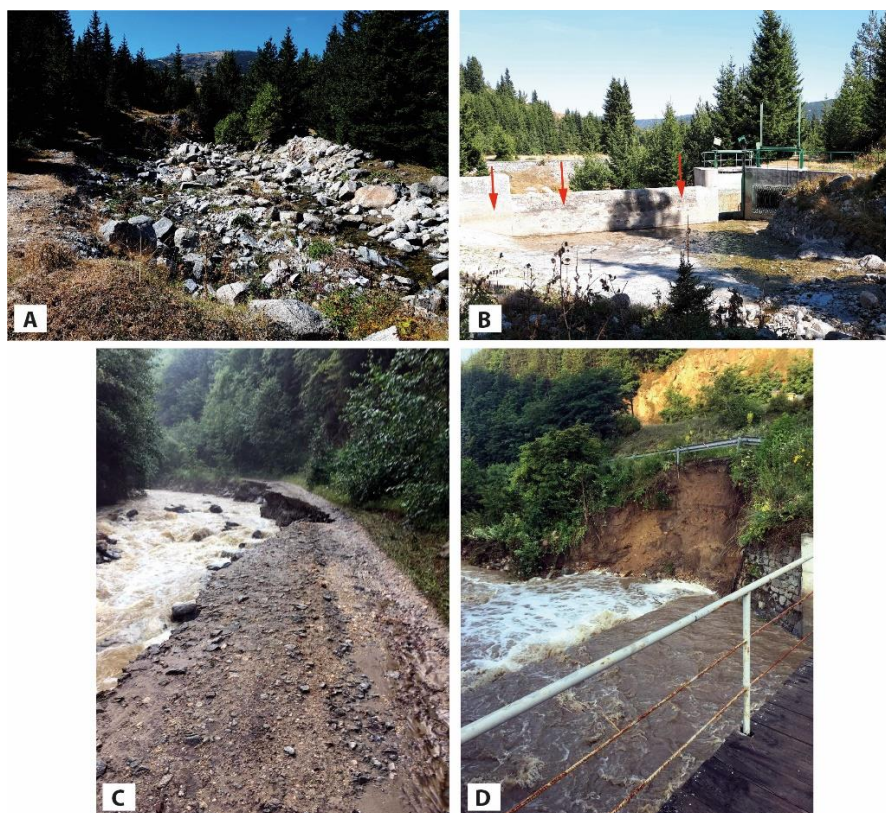
Fig. 2. (A) Deposition related to mid-2019 flood event just above the water intake for the Belmeken dam. Photo taken in September 2019. (B) The water intake weir for the Belmeken dam. Stains related to the accumulation of wet sediments are marked with red arrows. (C) The main river channel side erosion. The main access road for the Cherna Mesta catchment, above the power plant. (D) Partial collapse of road II-84 (Velingrad – Razlog). Photos (C) and (D) were taken on 23 July 2019 and were provided by the Yakoruda municipality.

The weir of this facility is located at 1,920 m a.s.l. (Fig. 1). The site was visited two months after the flood event of 22/23 July. There were clear signs that the space behind (upstream) from the weir has been recently filled with sediments. About 10

meters above the site, the river channel is filled with freshly-deposited clasts, and some of them are forming lateral levees (Fig. 2A). Considering the field criteria of (Brenna et al., 2020) and the low gradient of the river upstream of the weir, we interpret these sediments as a product of debris flood. Also, features such as sandy deposits at the level and above the crest of the weir, and yellow-rusty stains on the weir wall (Fig. 2B) testify to the long presence of wet debris and fresh cuts on the stonemasonry indicating a rather recent activity of the excavator. About 100 m below the facility, there is a bridge and below it, the river channel is starting to incise not only in Quaternary cover but also in the bedrock. Field data, such as fresh soil erosion and freshly polished bedrock, testify to the strong impact of the mid-2019 event in this part of the Cherna Mesta watershed.

This facility is located at 1,180 m a.s.l. and is situated at the confluence of the rivers that form the Cherna Mesta river. During the 22/23 July flash flood, the function of the structure was severely disturbed. The area behind the weir acted as a depocenter and the water intake system was completely clogged. According to the report from the guard of the power plant, it took one week of work of an excavator to clean the facility from the boulders, cobbles, and sand, deposited during the flash flood. This implies that at the time of the flood, the river deposited dozens of cubic metres of sediments.

these banks: flood-related stains on the recently-built concrete walls were found to be just 20-30 cm below the upper wall surface. The lower part of the village is not protected, and houses situated next to the river were flooded. In this sector of the river, there is evidence both of erosion and deposition. Erosional processes are strictly localised in the area below the end of the artificial banks (Fig. 3). The II-84 national road (Velingrad - Razlog) was closed due to the collapse of one of the lines (Fig. 2D).

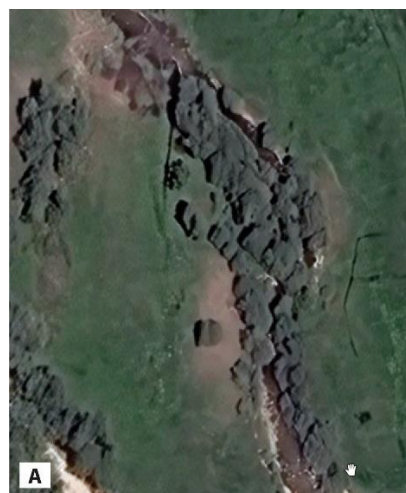
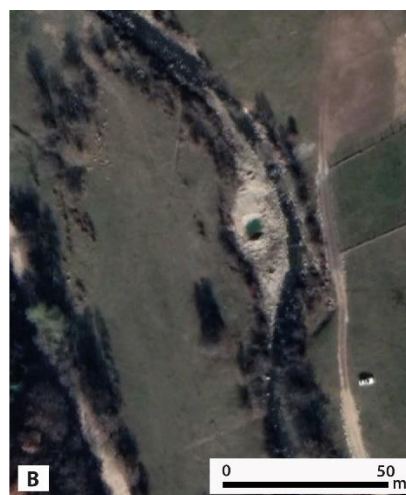
Fig. 4. The newly-formed depocenter immediately before the channelised part of the river in the area just north of the village of Cherna Mesta. Satellite imagery from Google Earth Pro: A – before the event (from 2016), B – after the event (2020).

Enhanced river erosion also causes partial removal of older alluvium further downstream. Two factors triggered this enhanced erosion capability of the river: the increased water speed due to the narrowing of the channel during the artificial banks construction, and the significant amount of bed load. Despite the low gradient of the river in the area of the village, the flash flood was able to carry a significant amount of sand and clasts. The deposits within the channelised part of the river are informative for the river capacity to carry bed load. Because during the recent construction of the artificial banks (2013-2017) all sediments on the riverbed were cleaned, it is easy to estimate of the volume and size of the clasts transported/deposited during the 22/23 July event. Field inspection conducted two weeks after the flood documented the presence of fresh deposits that were several dozens of meters long and up to 20 m wide, represented by coarse clasts reaching 0.5 m in diameter and abundant in sand sheets.
