DEBRIS FLOWS IN THE WATERSHED OF THE BOROVI TSA RIVER, THE EASTERN RHODOPE S

Radostina Rizova, Valentina Nikolova

University of Mining and Geology “St. Ivan Rilski”, 1700 Sofia; E-mails: r.rizova@mgu.bg; v.nikolova@mgu.bg

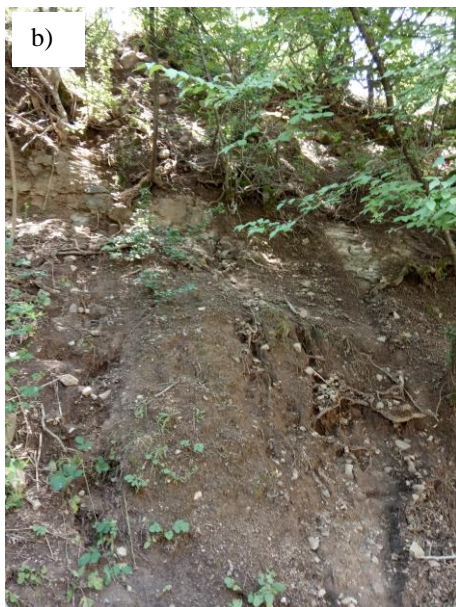
Fig. 3. Sample S1: a) grain size distribution; b) sampling site

Sample S1 – gully slope. The sample is trimodal, very poorly sorted. The gravel is the predominant fraction and takes 80.2% of the sample, the sand takes 19.8%. There is no mud fraction. The sediment is determined as coarse gravel, and the textural group is gravel. The grain size distribution is given in Fig. 3

Grain size distribution shows that there are samples with two and three modes. Sample S2, which was taken in the channel, before the check dam, is bimodal, while sample S3, which was taken after the barrage, is trimodal, but both have a main mode around $-2,5 \phi$ fraction (fine gravel). The sample, taken from the slope (source area), is trimodal, too, but the main mode is around $-4,650 \phi$ fraction (coarse gravel).

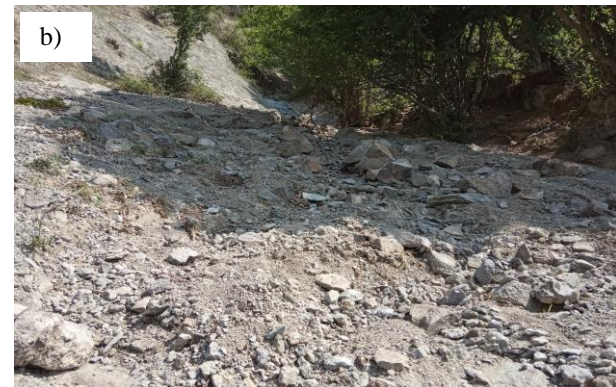
Fig. 4. Sample S2: a) grain size distribution; b) sampling site

Sample S2 – gully bed, before the check dam. The sample is bimodal, poorly sorted. The part of gravel is 60.9% of the sample, the sand takes up 39.1%. There is no mud fraction. The sediment is sandy fine gravel, and the textural group is sandy gravel. A view of the sampling site and the grain size distribution is presented in Fig. 4.

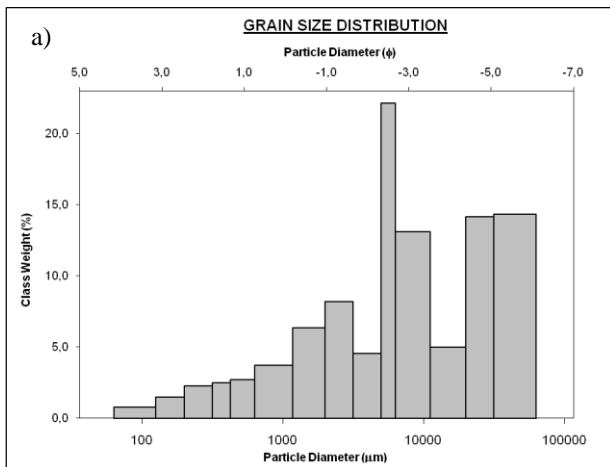
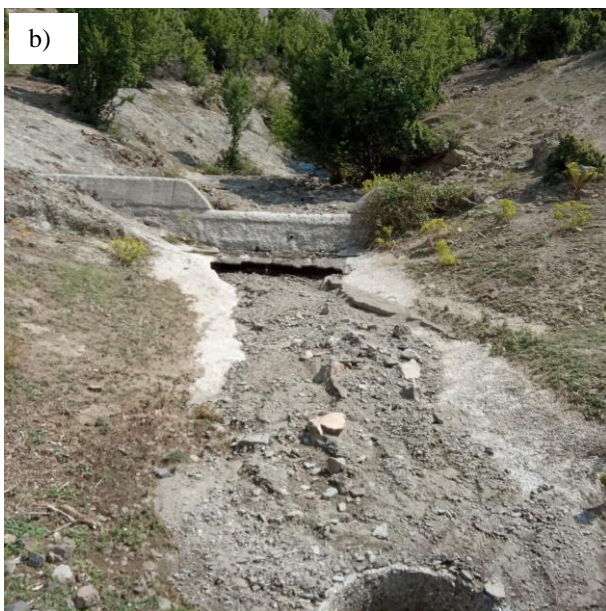
Fig. 5. Sample S3: a) grain size distribution; b) sampling site

Sample S3 – gully bed, after the check dam. The sample is trimodal, very poorly sorted. The gravel takes up 79.4% of the sample, and the part of the sand fraction is 20.6%. There is no mud fraction. The sediment is determined as sandy very coarse gravel, and the textural group is sandy gravel. The grain size distribution and view of the sampling site are given in Fig. 5.
