## RECOGNIZING DEBRIS FLOW HAZARD IN HEAVILY FORESTED WATERSHEDS: AN EXAMPLE FROM ETROPOLE AREA, CENTRAL BULGARIA

Zornitsa Dotseva<sup>1</sup>, Ianko Gerdjikov<sup>1</sup>, Nikolai Dobrev<sup>2</sup>, Dian Vangelov<sup>1</sup>

**Keywords:** debris flow, floods, natural hazard, GIS analysis, Quaternary deposits

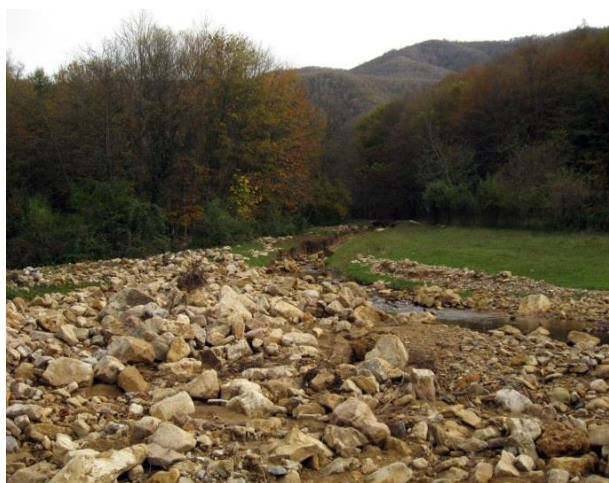
Fig. 3. Monastery River (24.03532 E, 42.83062 N) debris flow poorly sorted deposits; looking upstream

Reconnaissance field work was carried out three months after the event. Our field data shows that the river channels produced a sediment load, estimated to tens of cubic meter volume. Much of the sediments transferred from the channels were deposited in the area before the river channels inflow into

the Gnoynitsa River, forming distinct cones and levees. The debris flow deposits consist of very poorly sorted clastic material with boulder size up to 1 m (Fig. 3).

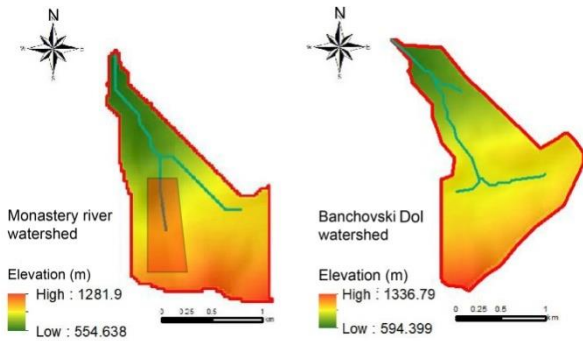
**Fig. 4. Watersheds DEMs: Monastery watershed with inactive part of the stream shaded in red (left) and Bančovski Dol watershed (right)**

While the Bančovski Dol Valley has a normal hydrological system, the Monastery River is strongly affected by karst processes. The upper part of the valley is completely dry and the active stream is initiated at the spring Ayazmoto, situated just next to the Monastery. Morphometric parameters of the studied watersheds were calculated and the results are presented in Table 1.

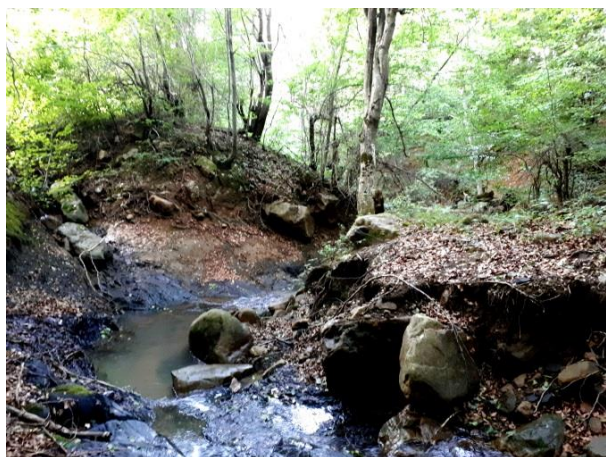
Fig. 5. Bančovski Dol (24.04826 E, 42. 83359 N) with landscape representative for the Middle domain: comparatively steep valley slopes, active channel cutting bedrock as well as unconsolidated older DF deposits

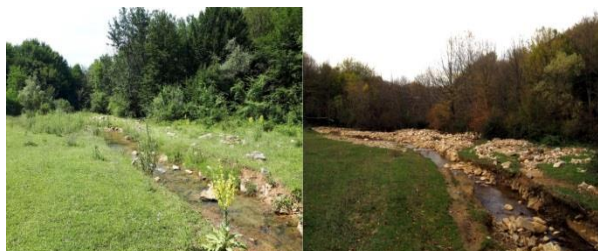
Fig. 6. Debris flow deposits from the 2014 event, Monastery River (24.03532 E, 42.83062 N): conditions in July 2019 (left) and October 2014 (right)

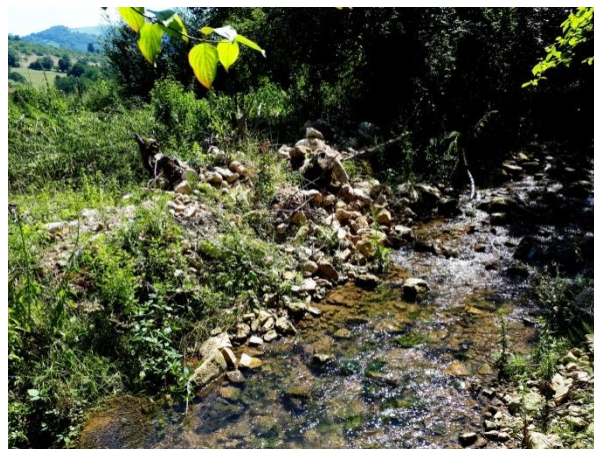
Fig. 7. Example of post-2014 deposits; meter-scale deposit situated next to the river curve, a place where during floods the river is attempting to make a cut-off chute (Eastern bank of Monastery River, 300 m above the confluence with Gnoynitsa River)

Post-2014 debris flows/floods deposits can be distinguished on the basis of complete lack of vegetation. They have small volume (up to few cubic meters) and form meter-scale levees immediately next or even within the stream channels. Most commonly the debris are accumulated next to the channel curves, where the flooded river is attempting to make a cut-off chute (Fig. 7). Probably some of these deposits are related to the floods in the area of Etropole in 2018.
